MACON LAKE DAM
MACON COUNTY, MO.
MO 10153

PHASE 1 INSPECTION REPORT NATIONAL DAM SAFETY PROGRAM

PREPARED BY: U.S. ARMY ENGINEER DISTRICT, ST. LOUIS

OCTOBER, 1980

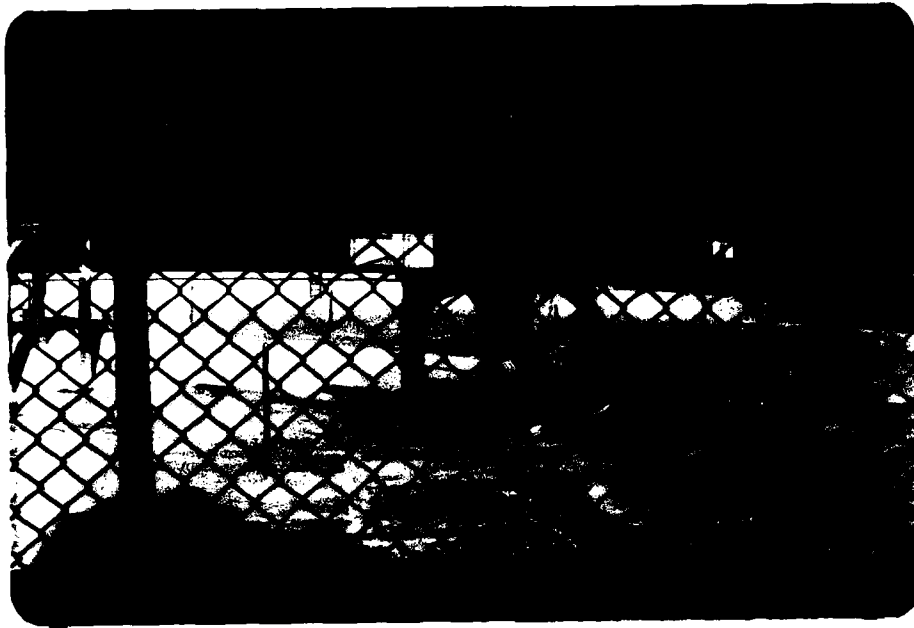
PHOTO NO. 32 - POOL AND WATERWORKS JUST BELOW THE DAM

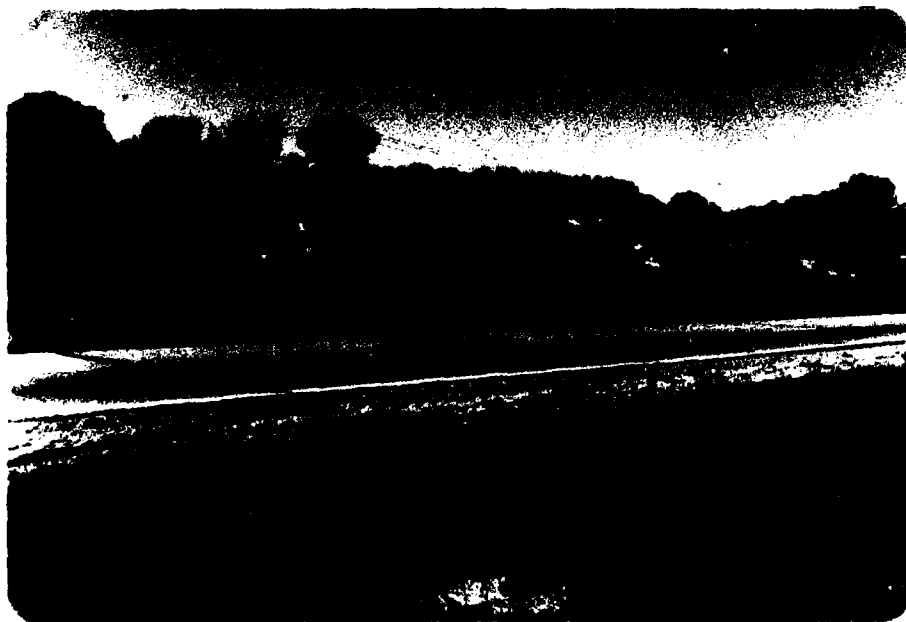
PHOTO NO. 33 - DOWNSTREAM HAZARD FOUR (4) HOUSES JUST EAST
OF THE WATER PLANT
